Manhole Inspection Summary

Manhole # S21E1_013MH

Insp Date: **5/22/08 12:25 PM**

Location Address: **2618 ridgely-huron alley**

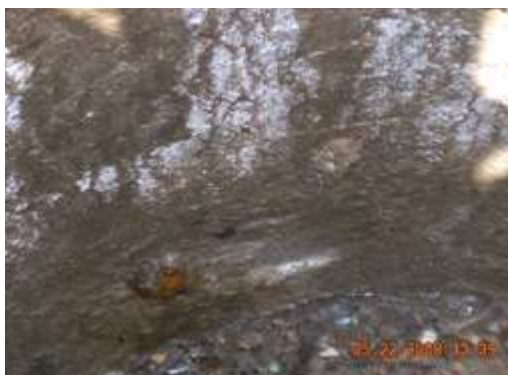
Defect 5

Infiltration: ☐ None ☐ Joint ☐ Cracks ☐ Mortar ☐ Roots ☒ **Wall**

infiltration @ barrel wall

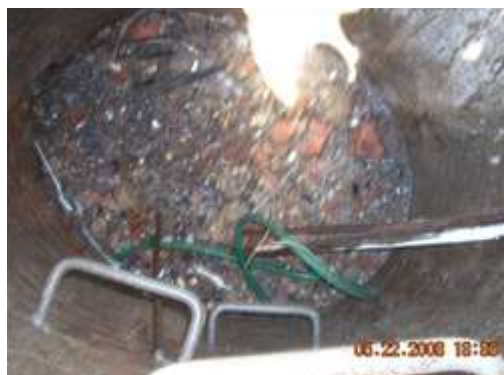
Defect 4

Condition: ☐ Sound ☐ Cracked ☐ Root Intrusion ☐ Deteriorated ☐ Leaks ☒ **Debris**

debris in terminal channel

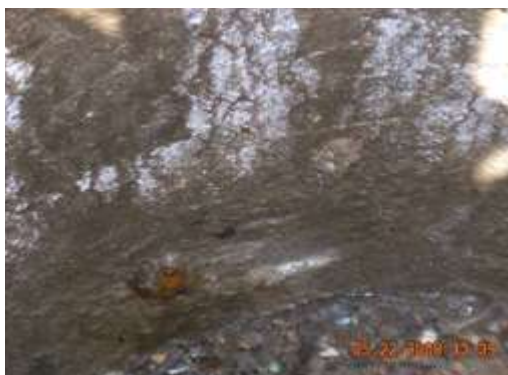
Defect 3

Condition: ☐ Sound ☐ Cracked ☐ Root Intrusion ☐ Loose Brick ☒ **Deteriorated**

encrustation/deterioration @ barrel wall

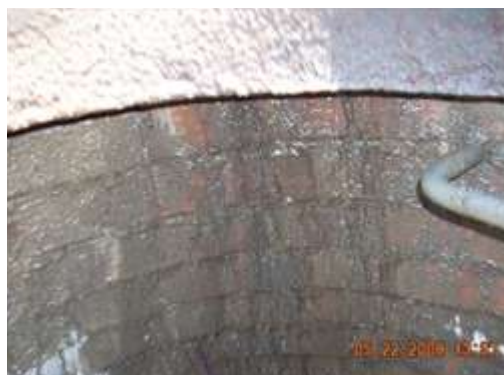
Defect 2

Infiltration: ☐ None ☒ **Joint** ☐ Cracks ☐ Mortar ☐ Roots ☐ Wall

infiltration @ corbel/frame joint

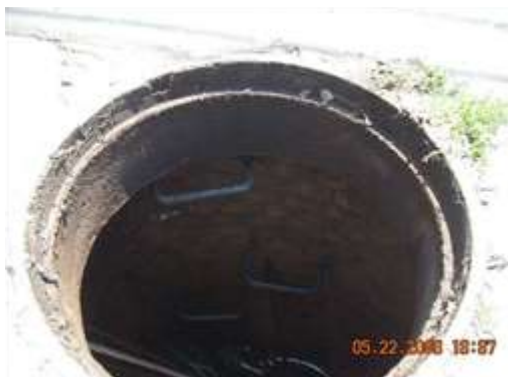
Defect 1

Subject To Ponding: **Sheeting**

inflow evidence from sheeting

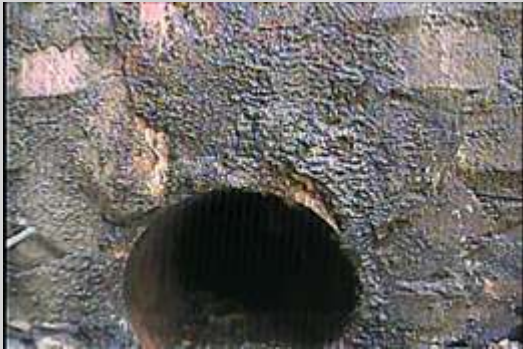
12 O'Clock Outflow

Deposits: ☐ None ☒ **Mud** ☐ Sludge ☒ **Debris** ☐ Grease

Silt Depth: **1** (in.) Deposits Extent: **Light**
